**EVALUATION OF INSTALLED
SOLAR SYSTEMS
AT NAVY, ARMY
AND AIR FORCE BASES**

NAVAL CIVIL ENGINEERING LABORATORY PORT HUENEME CALIFORNIA 93043

TN-1750 56 pp illus May 1986 Unclassified

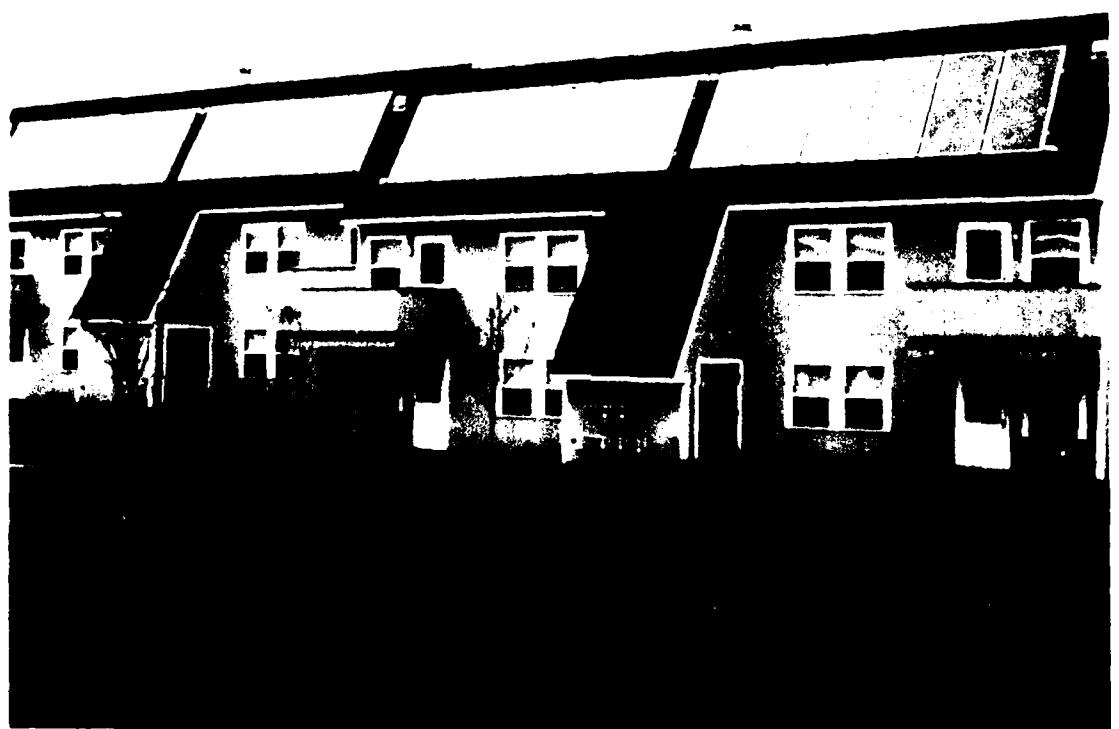
1. The solar collectors and tanks appeared to be in good condition.
2. There was a lack of accurate system drawings, hence no adequate preventive maintenance was performed.

3. There were a number of items that related to the initial system installation:
 - Insulation was missing from a number of pipes and joints.
 - There were some poorly soldered joints resulting in small leaks of the glycol solution.

- No dielectric unions were used resulting in dissimilar metal contacts which could cause problems in the future.
4. A design weak point is the lack of a circulating pump between the preheat storage tanks and main storage tanks. Standby losses are high and heat is transferred only when a demand is placed on the system. Performance could be improved if a pump were installed.

Figure 6. Four-plex units, Ballston Spa, N.Y.

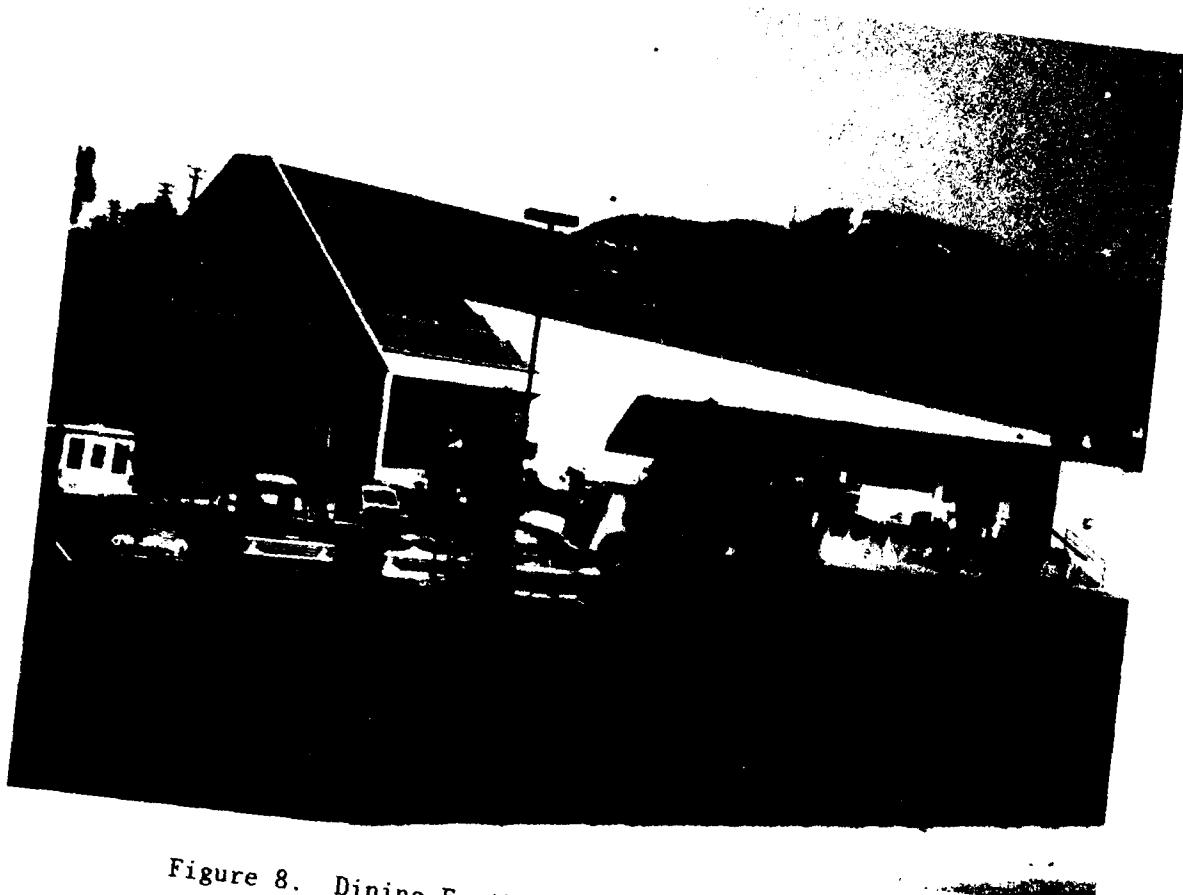
1. The glycol solution in the solar loop was low. There appeared to be air in the lines.
2. The storage tanks were slightly oversized at 2.9 gallons (storage) per ft² (collector area) vice about 1.8 to 2.0 gal/ft² optimum. No change is recommended, however.
3. The solar controls were interfaced with the EMCS controls. This is probably not the best approach since it leads to complexity of system control.
4. The solar collectors were fine and had normal flow. However, they were dirty due to the greasy air from the exhaust fans. They will have to be washed. It has also been a dry year, contributing to this problem.
5. It was advised to switch from a glycol loop to a recirculation loop for freeze protection to reduce the expense and volume of glycol needed.

Figure 8. Dining Facility, Camp Pendleton, Calif.

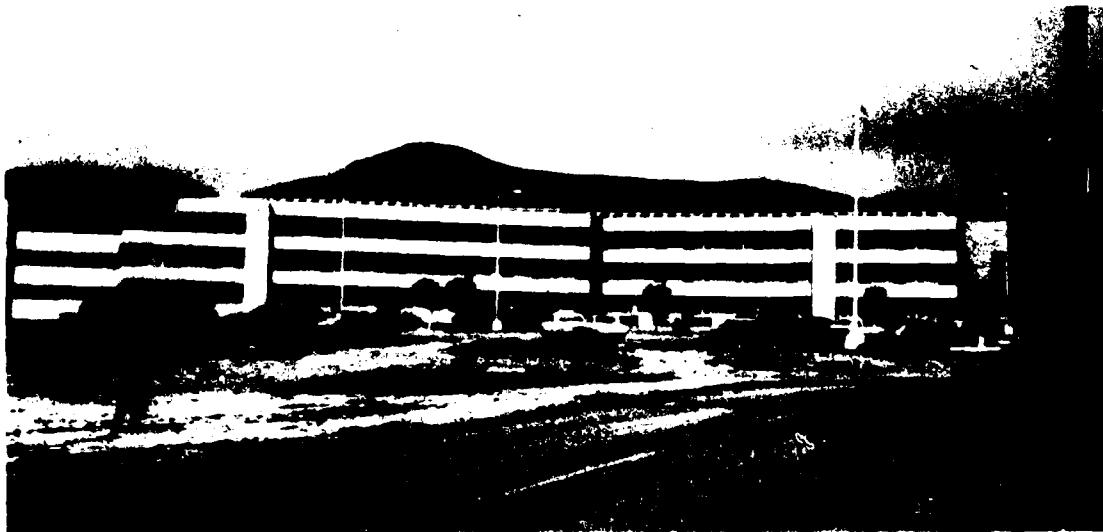
1. The piping runs were overly complicated which could contribute to poor flow distribution through the system.
2. One pump was not running due to control problems and one pump needed repair work.
3. The glycol in the system was low.
4. The solar collectors where fine and no major corrosion was noted.
5. The solar collectors were plumbed together with silicone hose and screw type hose clamps. They have had some leaks. NCEL has already recommended that constant tension hose clamps be used in place of screw type or that this method not be used at all.
6. During the first year of operation, several collector cover glazes cracked due to suspected thermal stresses. This problem is not recurring.

Figure 9. BEQ, Camp Pendleton, Calif.
